# Field Performance and Mitigation of Shredded Tire Embankment

STEVE GACKE, MELANY LEE, AND NANCY BOYD

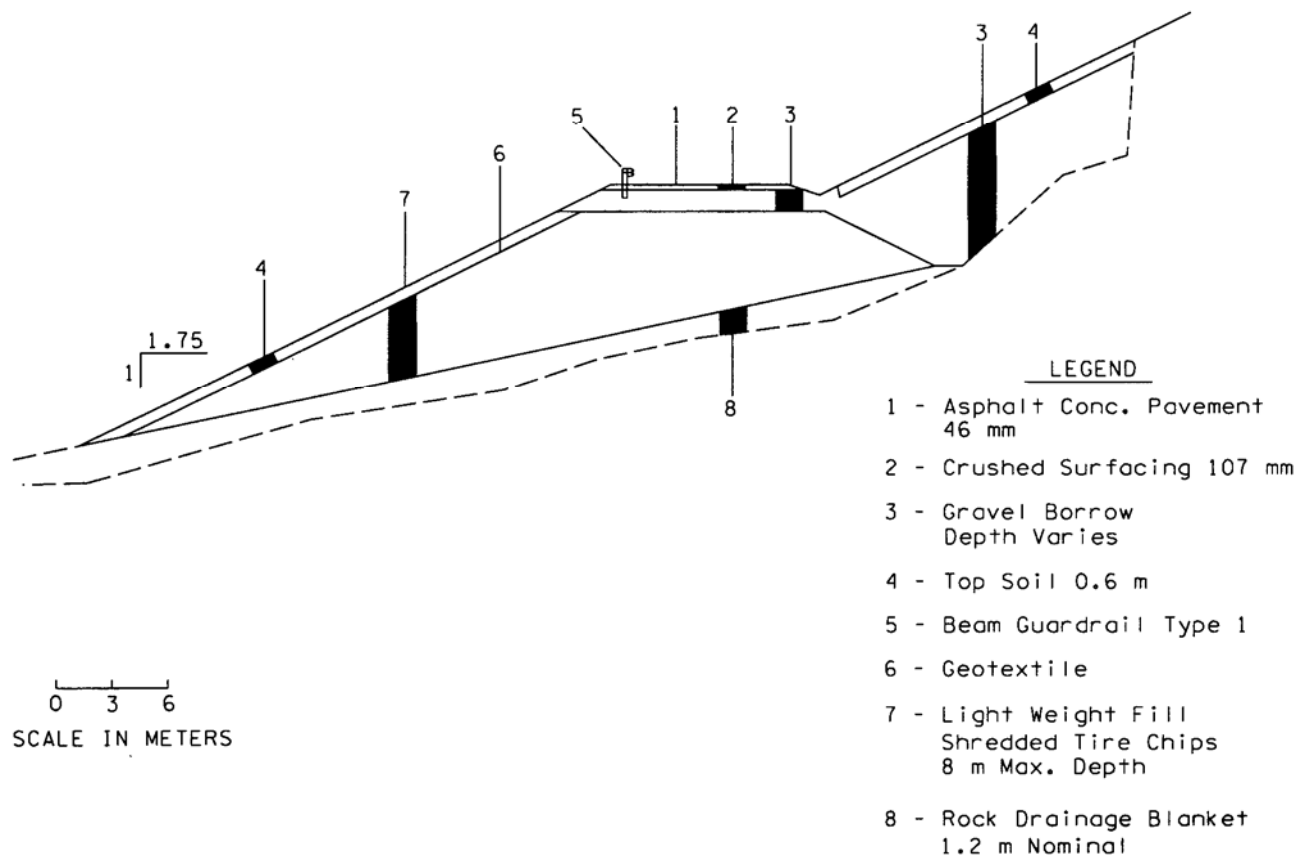
with shredded tires. It was recommended that a 1.2-m depth of gravel borrow material cap the shredded tires, with 0.3-m cover on the sideslopes (Figure 2).

**FIGURE 2** As-built section.

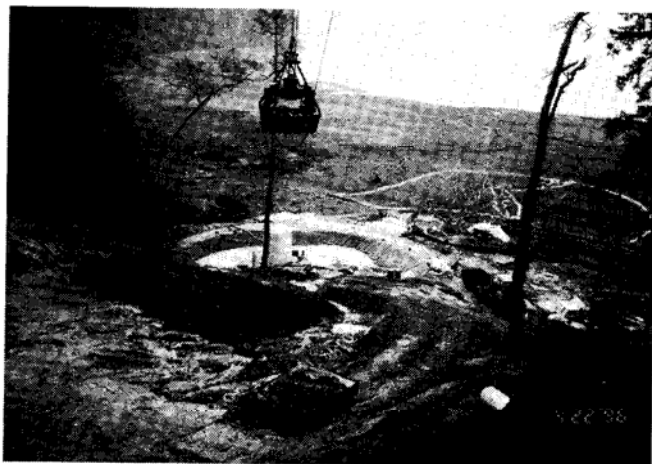
**FIGURE 3** Embankment excavation with berm and sorbent booms in background.

A semicircular containment berm was then constructed around the oil collection sumps, oil storage reservoir, and toe of the embankment. The berm was approximately 2 m high and had a maximum holding capacity of 378 500 L. Its inward and top surfaces were sealed with a 40-mil PVC welded-seam lining to ensure that all potential contaminants were contained.

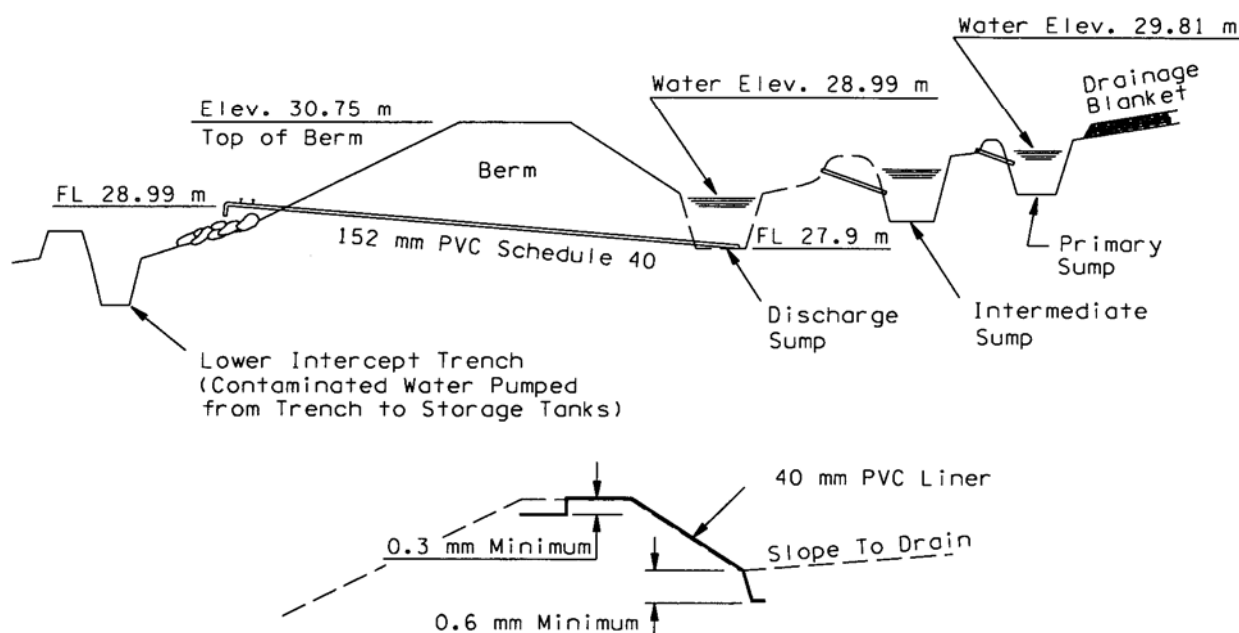
Water and oil collection sumps and trenches were used to collect all quenching and surface runoff, as the existing topography naturally drained to these facilities (Figure 4). Water pumped to Baker tanks was stored and recycled for quenching and for controlling fire outbreaks. A 15-cm-diameter, 2800 L/min water pump was plumbed to the Baker tanks to provide water for firefighting. Water monitors (cannons) fitted with 6-cm supply line were strategically located as primary fire control. The local volunteer fire departments provided backup for tire fire suppression and furnished protection for the adjacent old-growth trees.

FIGURE 4 Oil separation-water containment system (top); containment berm detail (bottom); all sumps and intercept trench lined with 10-mil polyethylene sheeting.

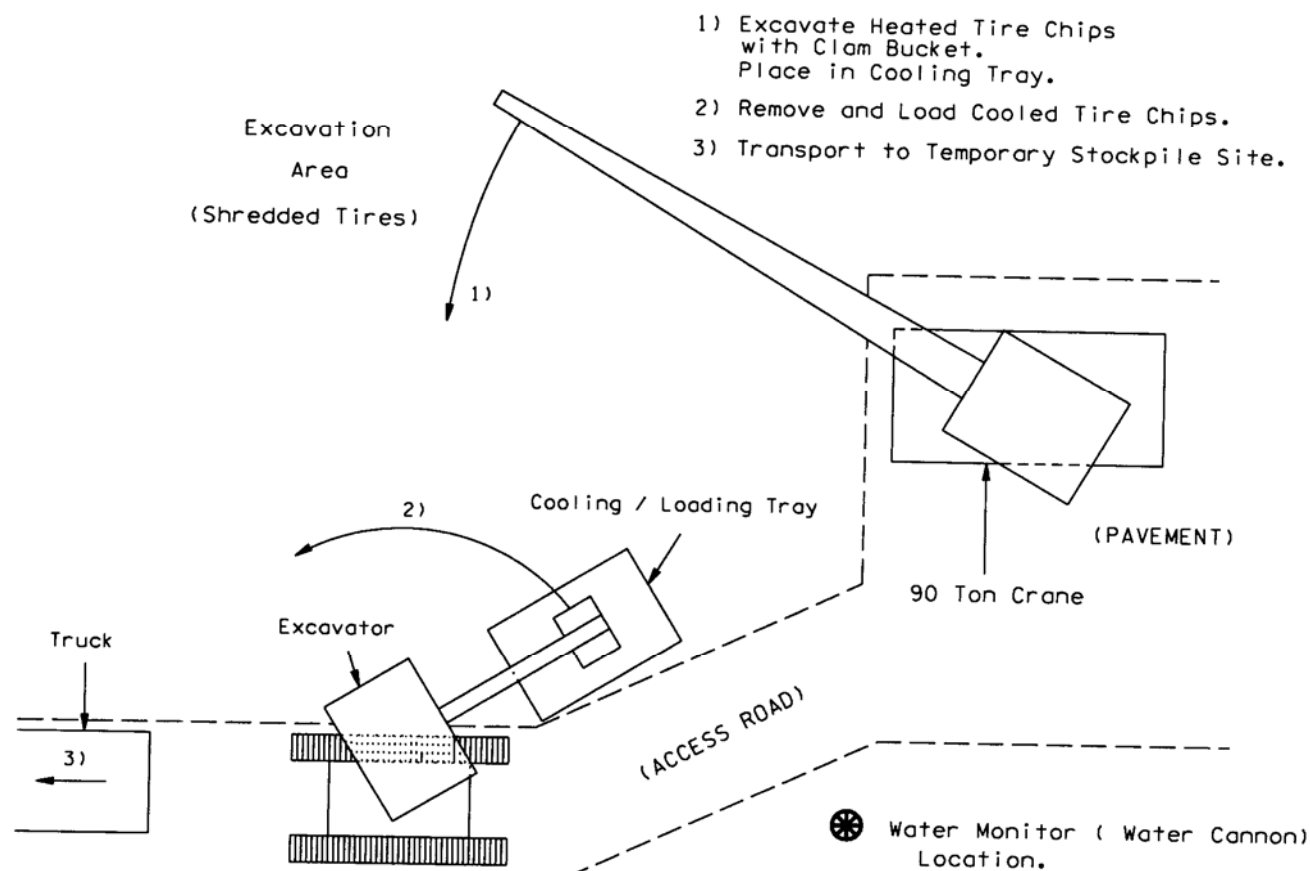
Infrared thermal imaging was used to locate the hot spots. The plan called for all excavation to be conducted by track backhoes (Figure 6) in the following stages:

FIGURE 6 Plan view of excavation sequence.

1. Remove the headscarp backfill level with the pavement surface and remove the rail element of the guardrail.

2. Remove asphalt concrete pavement, crushed surfacing top course, and gravel borrow to approximately the top of lightweight fill and remove guardrail post; and test surface stability with the trackhoe bucket by point loading any area before placing equipment on it.

3. Remove approximately 1.6 m of tire chips.

4. Isolate the two distinct hot spots by removing unaffected chips around the perimeter and to the bottom of each hot spot; remove hot spots in a layered manner, controlling fire flare-up with suppression equipment; cool chips by immersing in a water bath as needed and spreading in a cooling/loading tray; and load and haul cooled material to the stockpile site.

5. Remove remaining unaffected chips and haul them to the stockpile site.

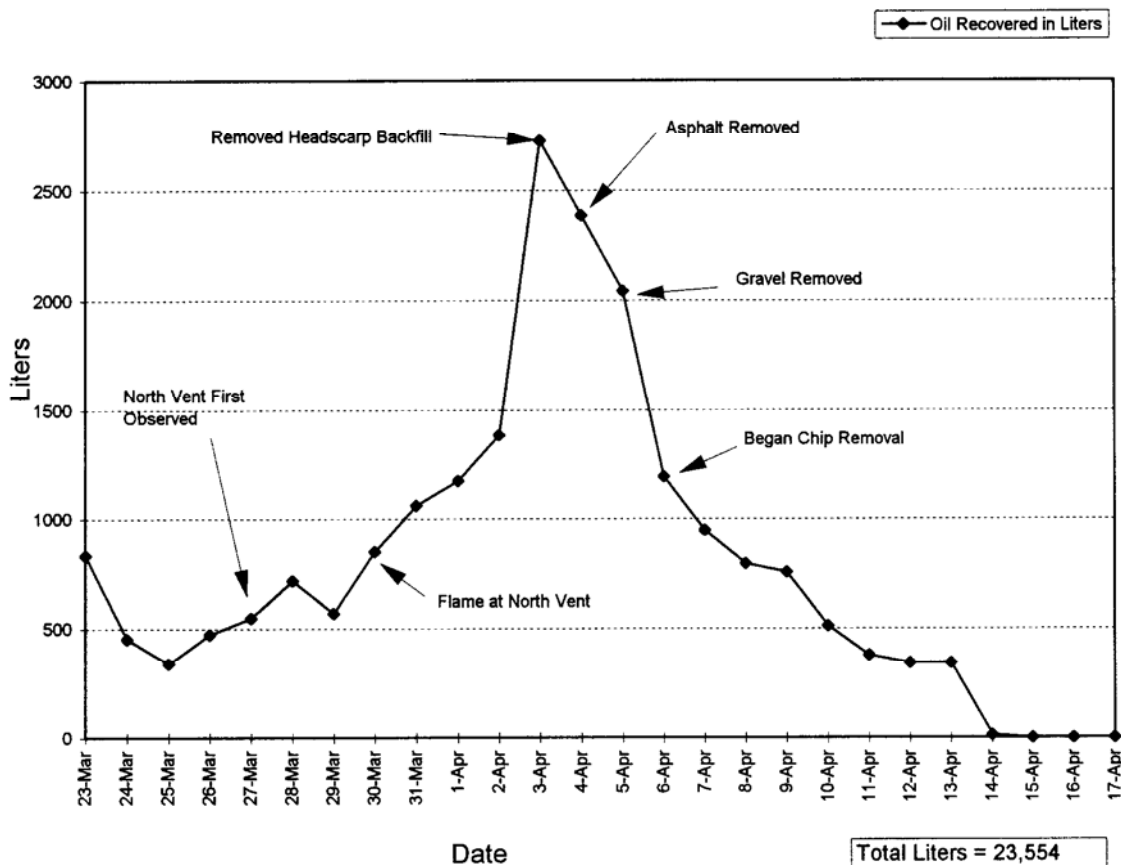
Oil recovery was measured, recorded, and plotted on a graph daily, and key events were annotated as they occurred. An immediate reduction in oil production was documented after the asphalt was removed (Figure 7). In other words, when the cover overlying the tires was removed, allowing free access to oxygen (and therefore allowing full combustion to occur), oil production dramatically and immediately decreased.

FIGURE 7 Oil recovery chronology.
